CITY OF HUNTINGTON, INDIANA

Americans with Disabilities Act Self-Evaluation and Transition Plan

June 2013

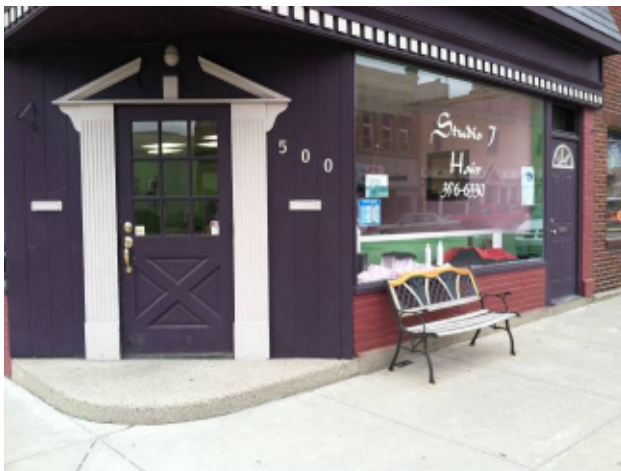
Example of common access issues to local business in the downtown. This location has a step to the entrance, inadequate landing size, non-compliant door hardware, and lack of space on pull side of the door.

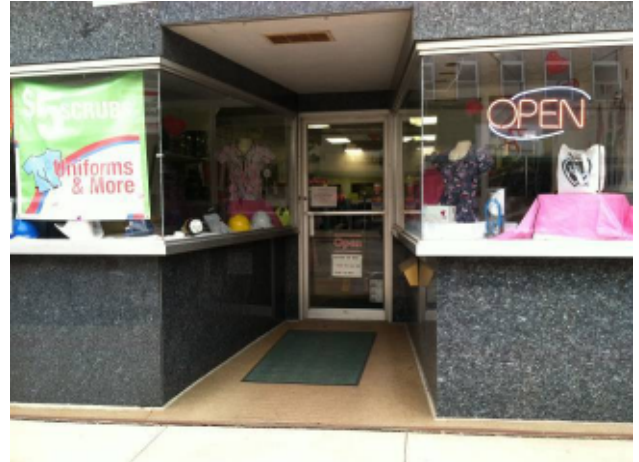
This location has a sloped path to the front door with no level space at the door and door has glazing too low. This would make access to a wheelchair very difficult.

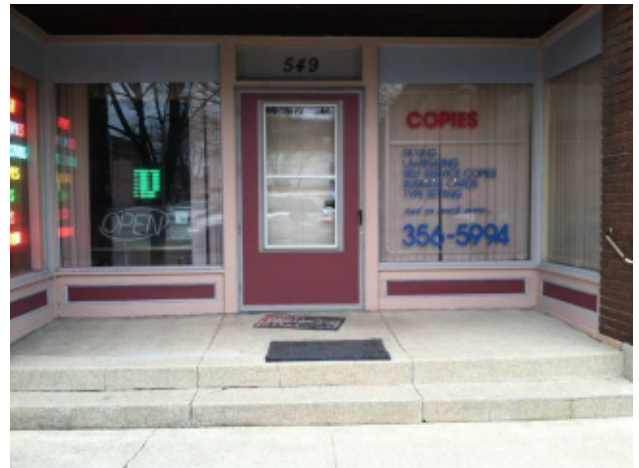
Several businesses have multiple steps to traverse from the public sidewalk.

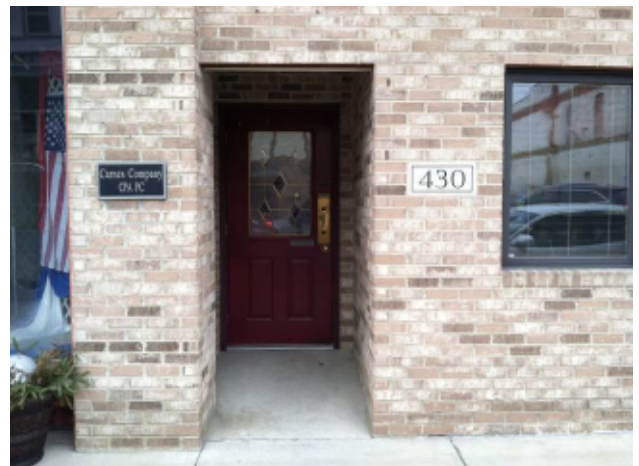
Recessed door with no pull side space. Possible option to have door swing into the building to correct.

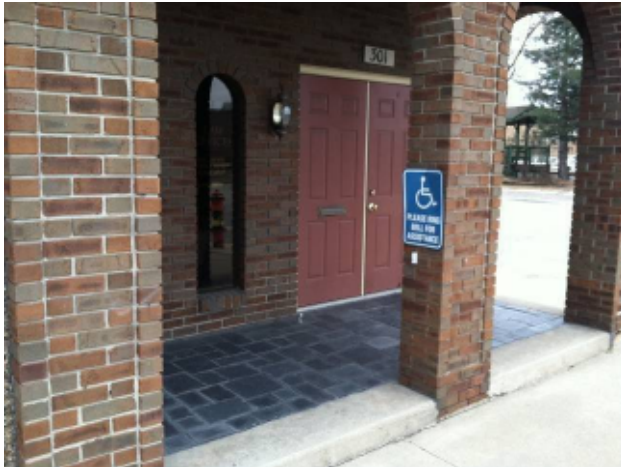
Attempt to provide access to an inaccessible door with a step and non-compliant hardware. Note sign is only visible when approached from one direction.

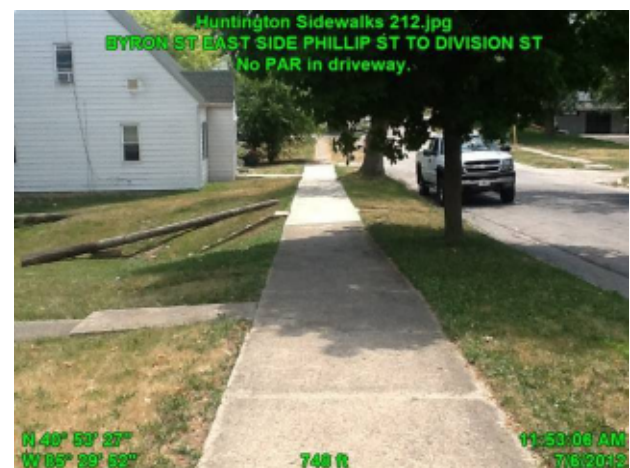
Photo: Example of 5' sidewalk width

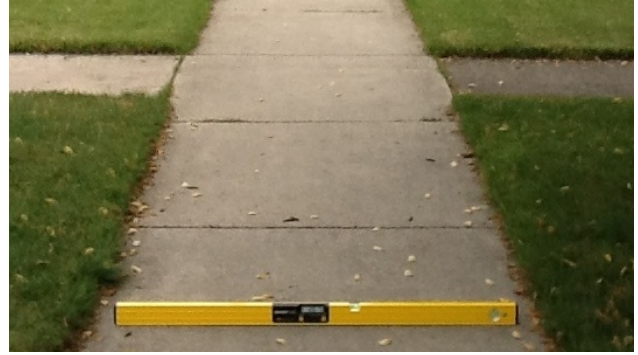
Example of Cross Slope Data Collection

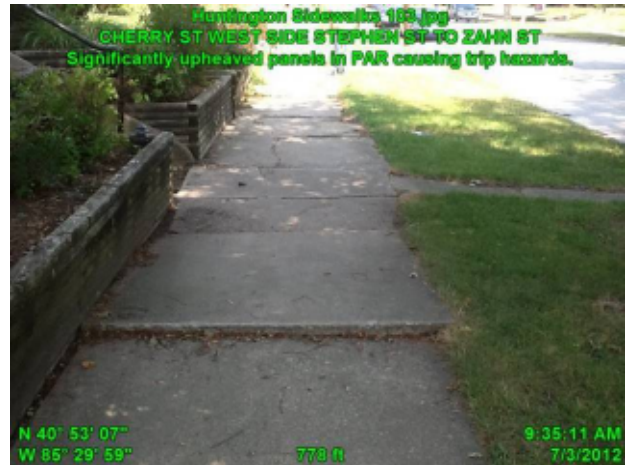
Examples of changes in level observed within the City include settling, heaving due to frost, and displacement from adjacent tree growth.

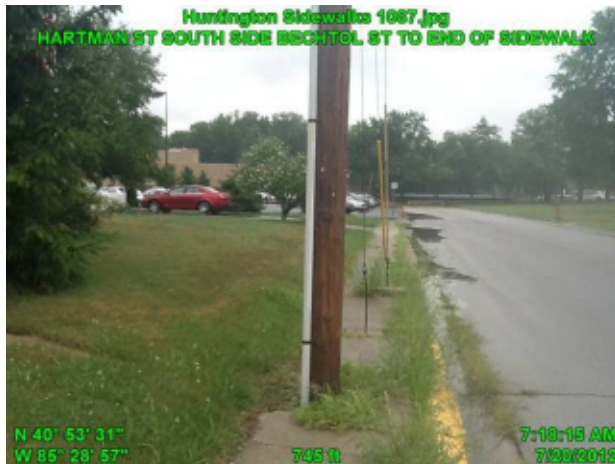
Example of Utility Obstruction narrowing sidewalk width to under 48" minimum required

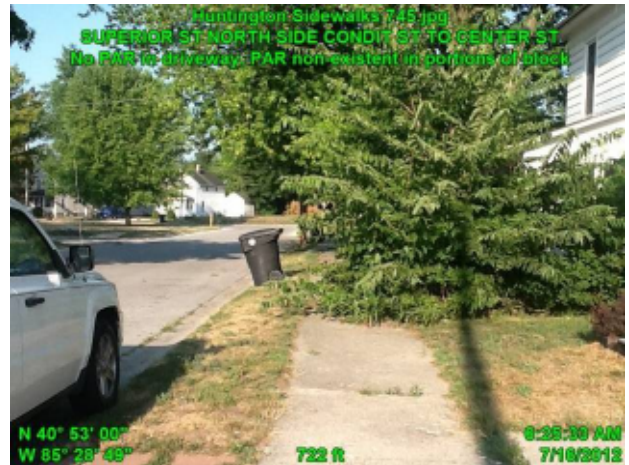
Example of vegetation protruding into PAR

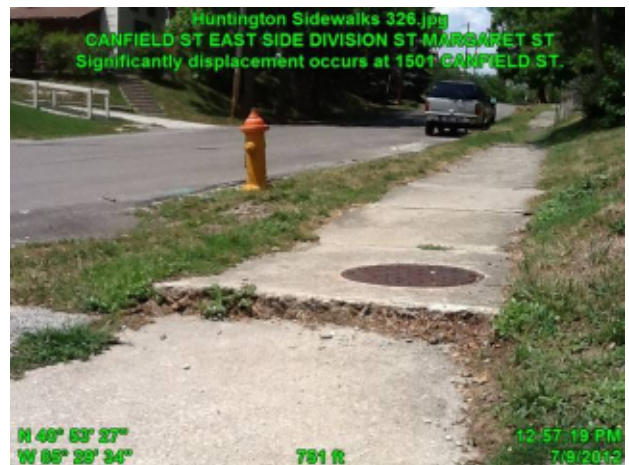
Photo: Example of ground plane utility conflicts as displacement and slip/trip hazard

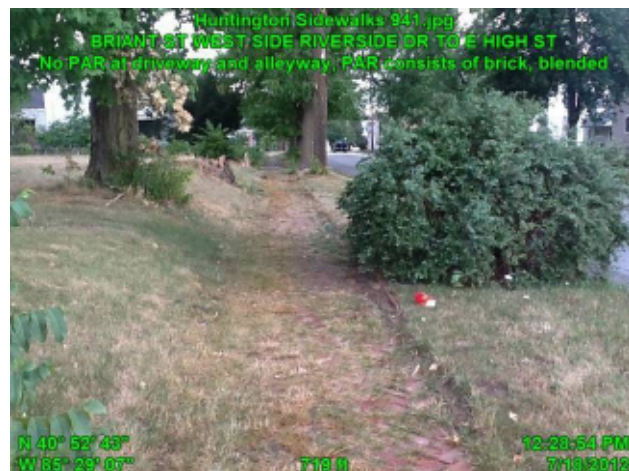
Photo: Example of poor surface (brick) that has not been maintained and has extensive areas of vegetation, which are surface level changes and present a difficulty for a wide variety of users.

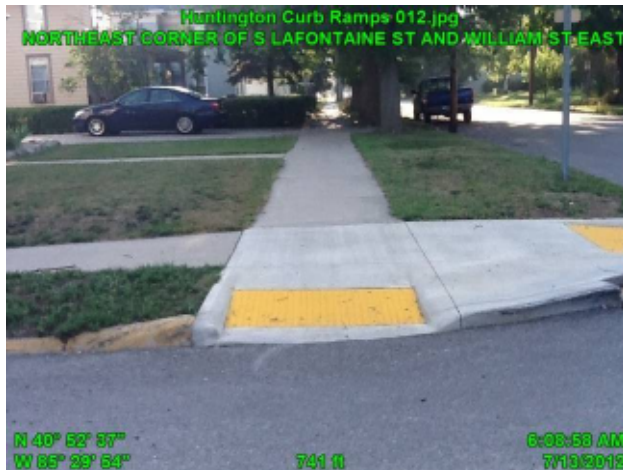
Photo illustrates common misuse of flares. Flare to lawn is not necessary. Outer flare is too steep creating trip hazard.

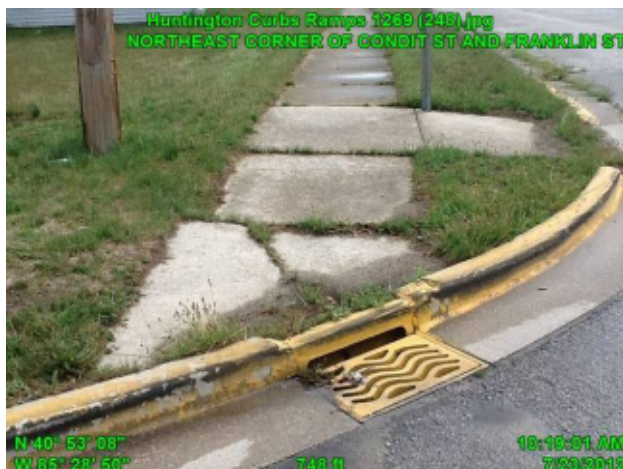
Photo illustrates drainage structure located within crossing location. Gaps in the structure exceed 1/2" allowed by PROWAG.

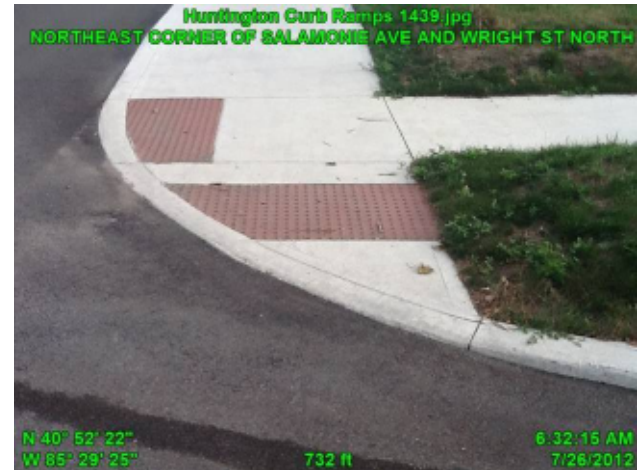
Photo illustrates common misuse of detectable warnings. Warnings to extend entire width of area flush with street and 24" deep minimum. Example provides gaps which could be missed by pedestrian with low vision. Orientation is desired for directional cues.

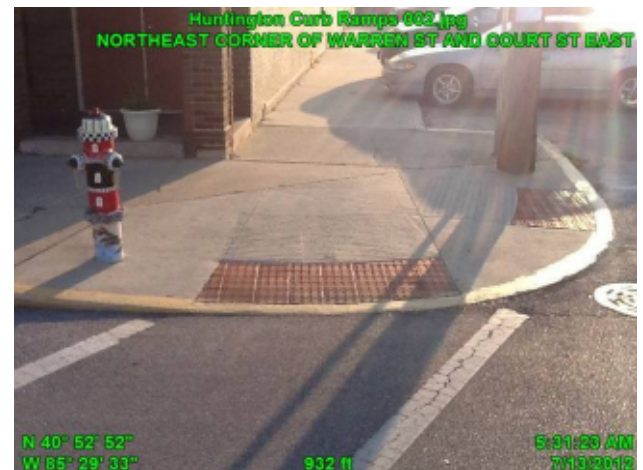
Photo illustrates proper location of detectable warning on blended transition but entire curb is flush. Note that truncated domes have been sheared off and no longer serve intended purpose. Orientation of domes is desired to be parallel to travel path.

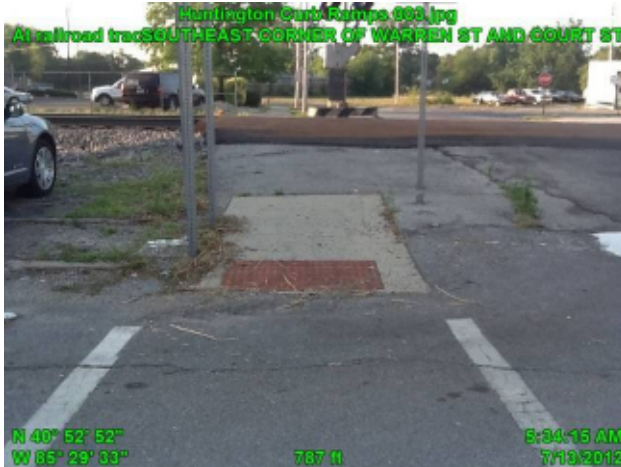
Photo illustrates issues at railroad crossing near adjacent street. Detectable warning can only provide warning for one direction (in this case the street crossing). Warnings also required at railroad.

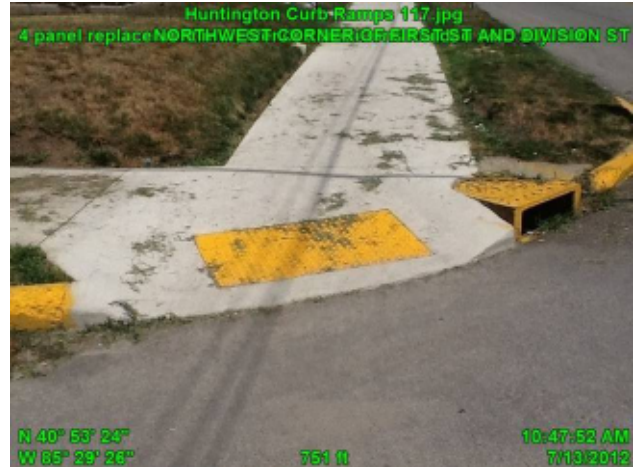
Photo illustrates typical case where no landing exists due to ROW limitation or other physical constraint.

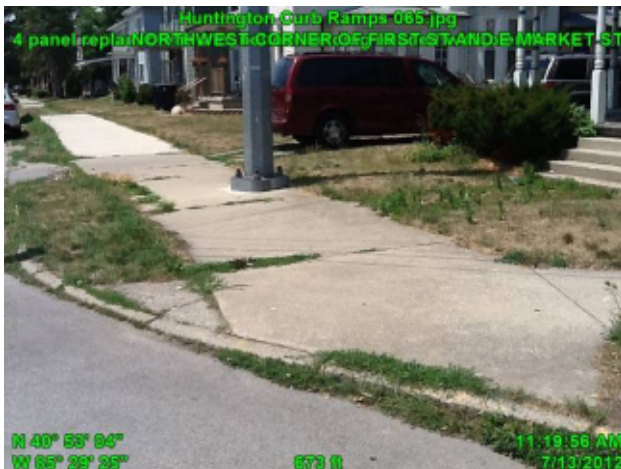
Photo illustrates common issue in older neighborhoods. No detectable warnings, no landings, non-compliant cross and running slopes. Utility pole location complicates solution as potential obstruction of PAR.

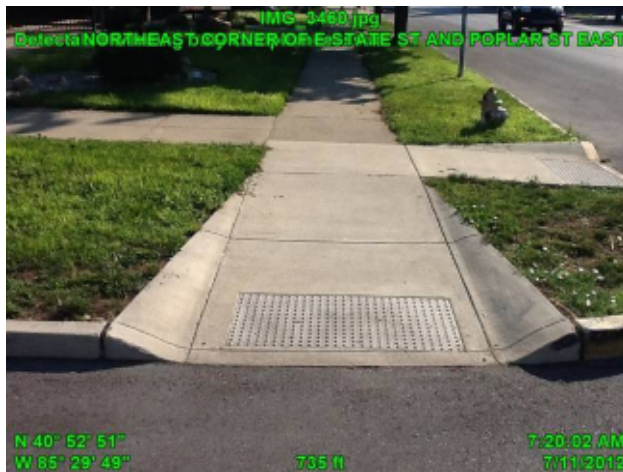
Cost Group 1 Example

Cost Group 1 – Locations where only minor non-compliant issues need to be corrected. This work may include removal of flare, grinding curb, removal of necessary pavement panels, or addition of detectable warning.

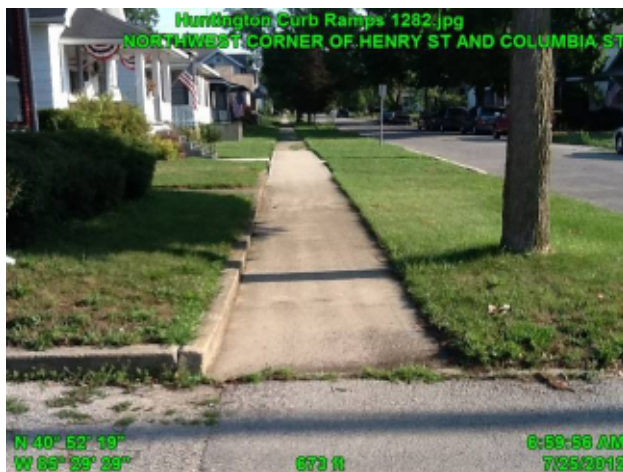
Cost Group 2 Example

Cost Group 2 - Locations where only non-compliant criterion was detectable warning. Work would include removal of the single panel and replacement with one panel of concrete, including detectable warning plate.

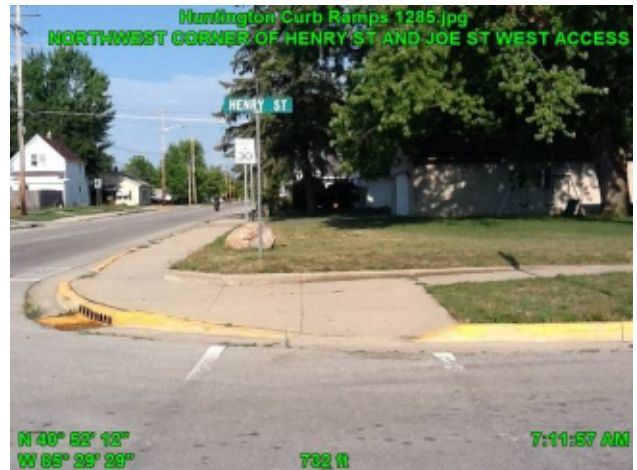
Cost Group 3 Example

Cost Group 3 - Ramp Reconstruct, Basic (Ramp Only, no ROW issues, no sidewalk impacts): Work includes correcting slope issues, removal of ramp and landing,

reconstruction to provide a compliant, level landing and ramp that connects with detectable warning plate.

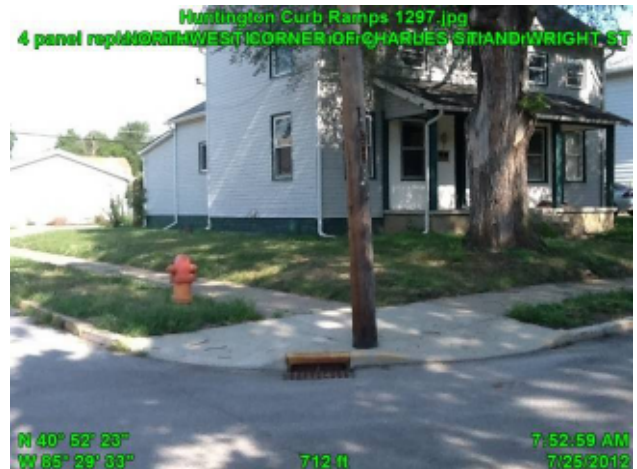
Cost Group 4 Example

Cost Group 4 - Ramp Reconstruct, Moderate (Ramp, 2 panel sidewalk each side, No ROW issues): Work would include same as Cost Group 3 but due to greater slope issues, would also include concrete sidewalk panels to each side of the ramp to correct.

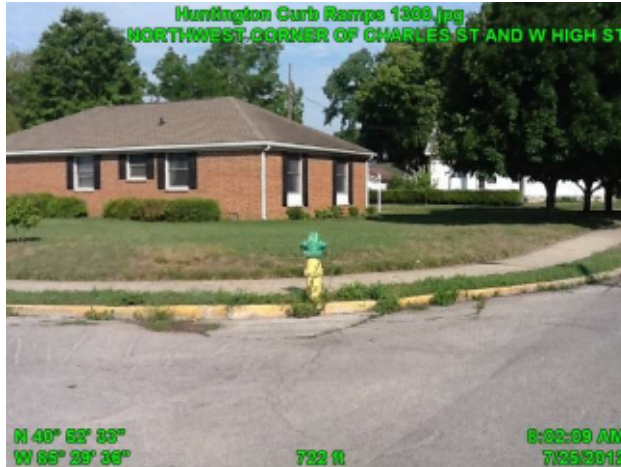
Cost Group 5 Example

Cost Group 5 - Ramp Reconstruct, Major (Ramp, 3-5 panel sidewalk each side, No ROW issues): Work would include same as Cost Group 3 but due to greater slope issues, would also include several concrete sidewalk panels to each side of the ramp to correct.

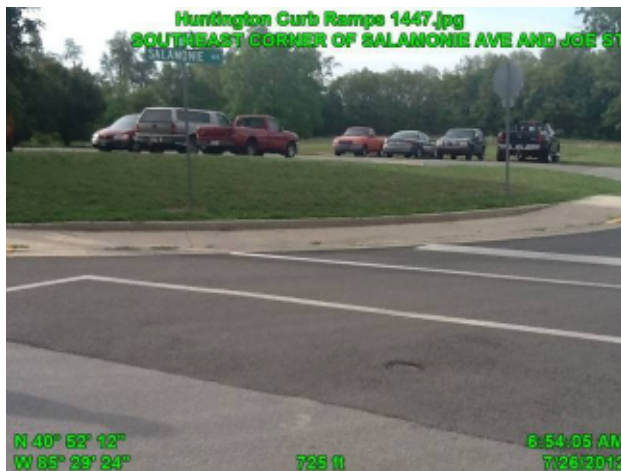
Cost Group 6 Example

Cost Group 6 - Ramp Reconstruct, Parallel (Change ramp to Parallel configuration due to ROW limiting landing availability): Work would include removal of existing ramp, reconstruction to convert to a parallel ramp, including a level landing coming off the crosswalk, ramps in each direction to tie into existing sidewalk, additional sidewalk panels as needed, and detectable warning plates.

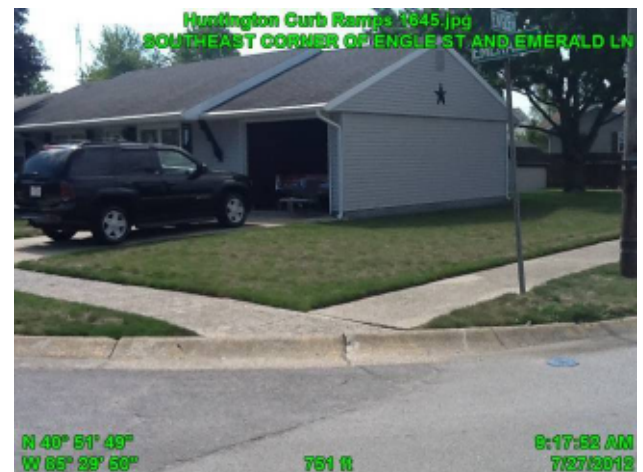
Cost Group 7 Example

Cost Group 7 - Ramp Reconstruct, ROW (Flagging of potential ROW needs, Limited application, ROW acquisition costs not included): This category is included in order to flag locations where ROW may be needed to construct compliant ramps. These will need to be looked at on a case-by-case basis to determine extent of work, ROW required, and technical feasibility of creating a compliant ramp. This cost group may also include ROW limited locations where conversion from one ramp to two perpendicular ramps alleviates the deficiencies.

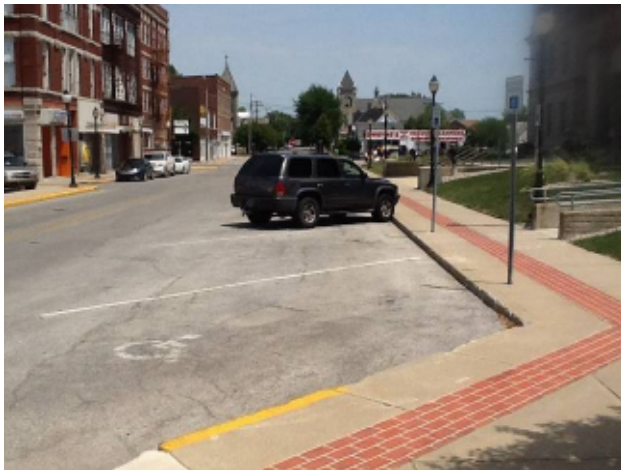
Photo illustrates on-street angled parking on Franklin St. Access aisles not provided between adjacent spaces.

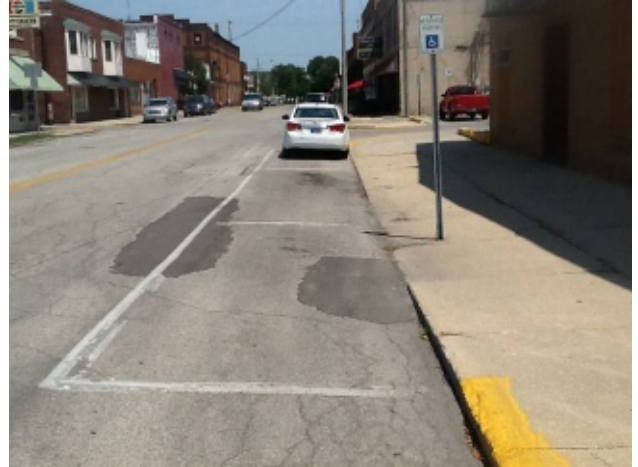
Photo illustrates on-street parallel parking with proper signage. Space located at intersection.

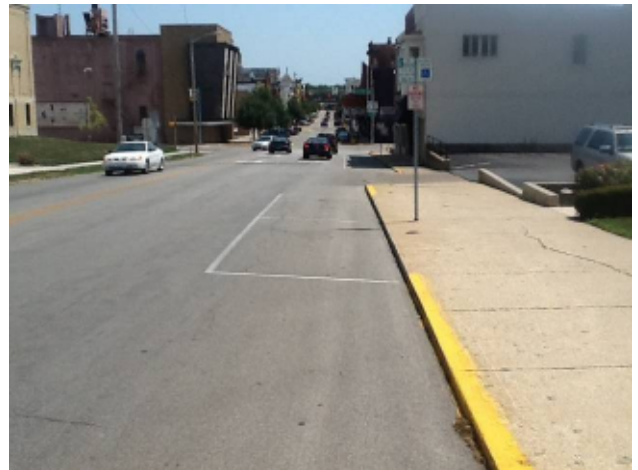
Photo illustrates on-street parallel parking on Jefferson St. Parking space slopes would make it extremely difficult for wheelchair user.

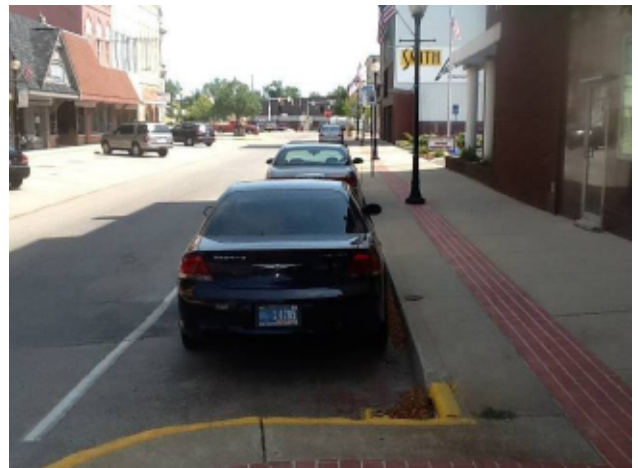
Photo illustrates on-street parallel parking on Jefferson St. Space with barrier-free sign not near curb ramp.

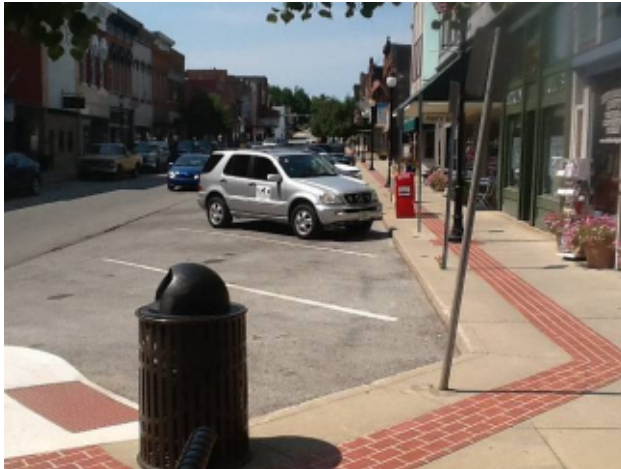
Photo illustrates on-street angle parking on Jefferson St. Space has required sign but no access aisle is present and width of space is not sufficient to allow access to curb ramp.

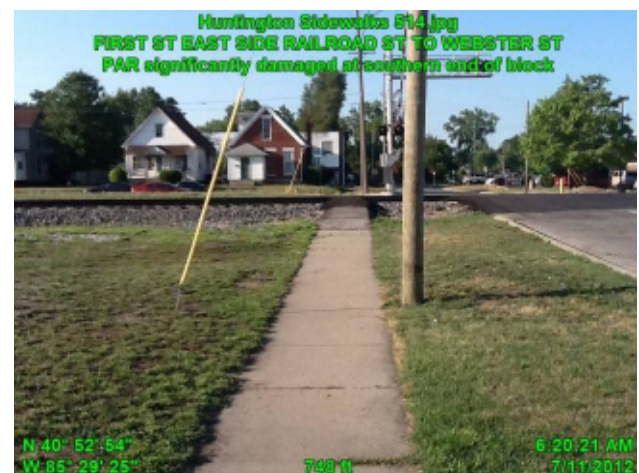
Photo shows typical condition at rail crossings within City with excessive slope and no detectable warnings.

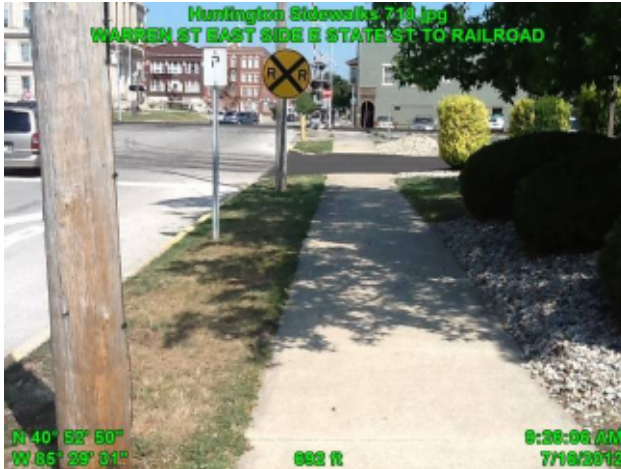
Photo shows typical condition at rail crossings within City for crossing with compliant slope but no detectable warning.
