Memorial Park Conceptual Master Plan

City of Huntington, Indiana May 2014

> Prepared by: DLZ Indiana, LLC Fort Wayne, Indiana

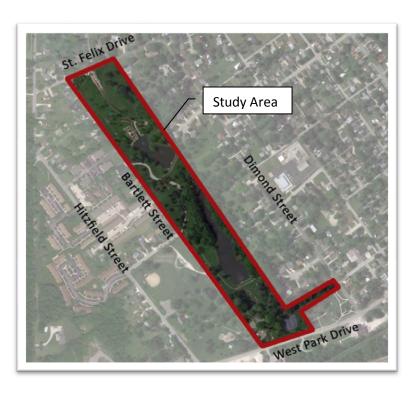
A field inventory was conducted along with a general site analysis of the study area examining existing conditions of the site and park features. The study area is shown in the illustration to the right.

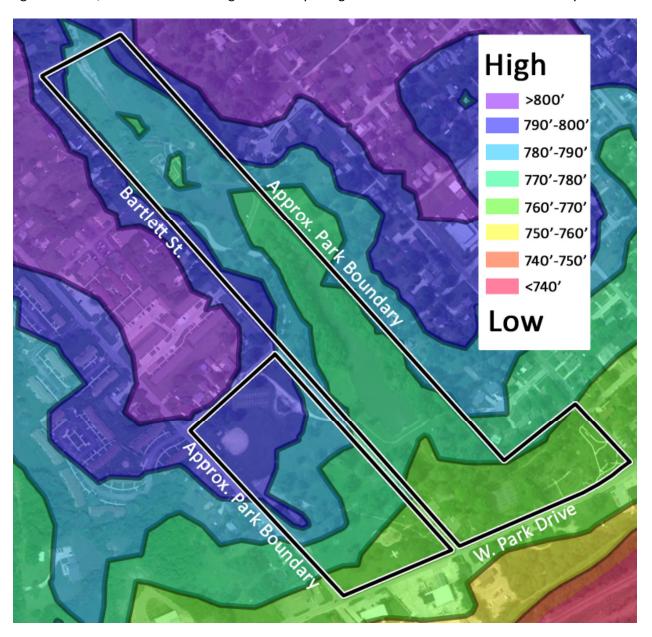
Slopes within the Park vary widely. Approximate elevations range from 750 (feet above sea level) at the south end along West Park Drive to 795 at the north end along St. Felix Drive. The graphic below illustrates the grade change across the site. The grade changes provide opportunities for desirable views within the park, but present a challenge for locating improvements that require level areas of any significant size, as well as maintaining accessibility along walks and to and from areas of activity.

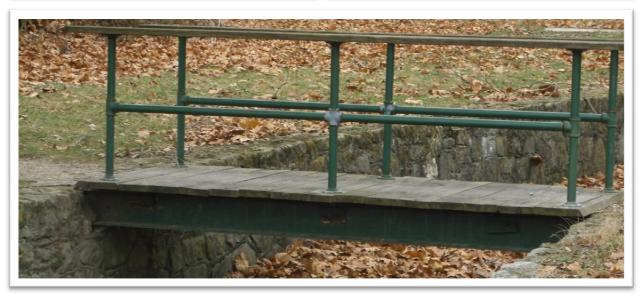
Based on preliminary observations, these two bridges spanning the WPA channel are composed of different materials. Both structures span the channel and have an approximate length of 10 feet. The southernmost bridge (below, red railing) is composed of three 6" timber beams with 2" deck planks and metal tube railings with a timber cap. The clear width between railings is just over 4'-6". The existing timber plank deck is in good condition. The bridge just north of the tennis court (below, green railing) is composed of steel I-beams with 2" deck planks and metal tube railings with a clear width between railings of slightly less than 3'-4".

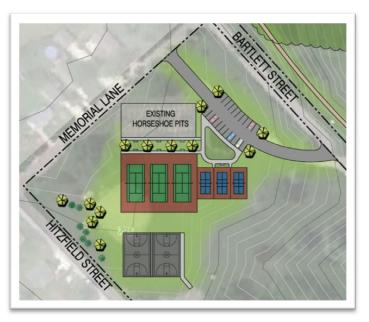
A new court sport complex would be provided on the west side of Bartlett Street as shown to the right. In addition to the relocation of the tennis courts, separate pickleball facilities would be provided. Two basketball courts would also be provided near the existing parking and shelter to replace the courts currently located between the south parking lot and the WPA stone channel. All courts would be lighted.

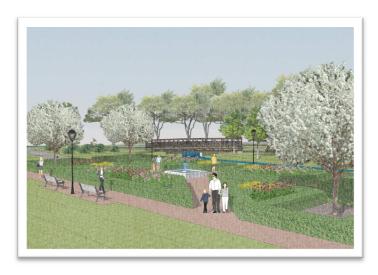
The City desires to convert the Arborial fountain basin into an at-grade planting bed. The basin's bottom would be altered to allow drainage and backfilled with an appropriate drainage material and soil medium. The existing border's stone work would be

repaired in kind and remain as the planting bed border. The Arborial Garden could be accented with low evergreen plantings and limited high impact plantings at the walk connections. The Waltonian Garden and the upper pond area are currently slated for improvement in 2015 per the latest Parks Master Plan.
